**Visions In Education**  
**TENANT IMPROVEMENT PROJECT**  
**Project # 24-01**  
**ADDENDUM NO. 1**

**Replace** the following sheets identified as ADDENDUM 1: 4-30-24

VISIONS IN EDUCATION  
TENANT IMPROVEMENT  
1931 FOUNDATION PLACE  
GOLD RIVER, CA. 95670

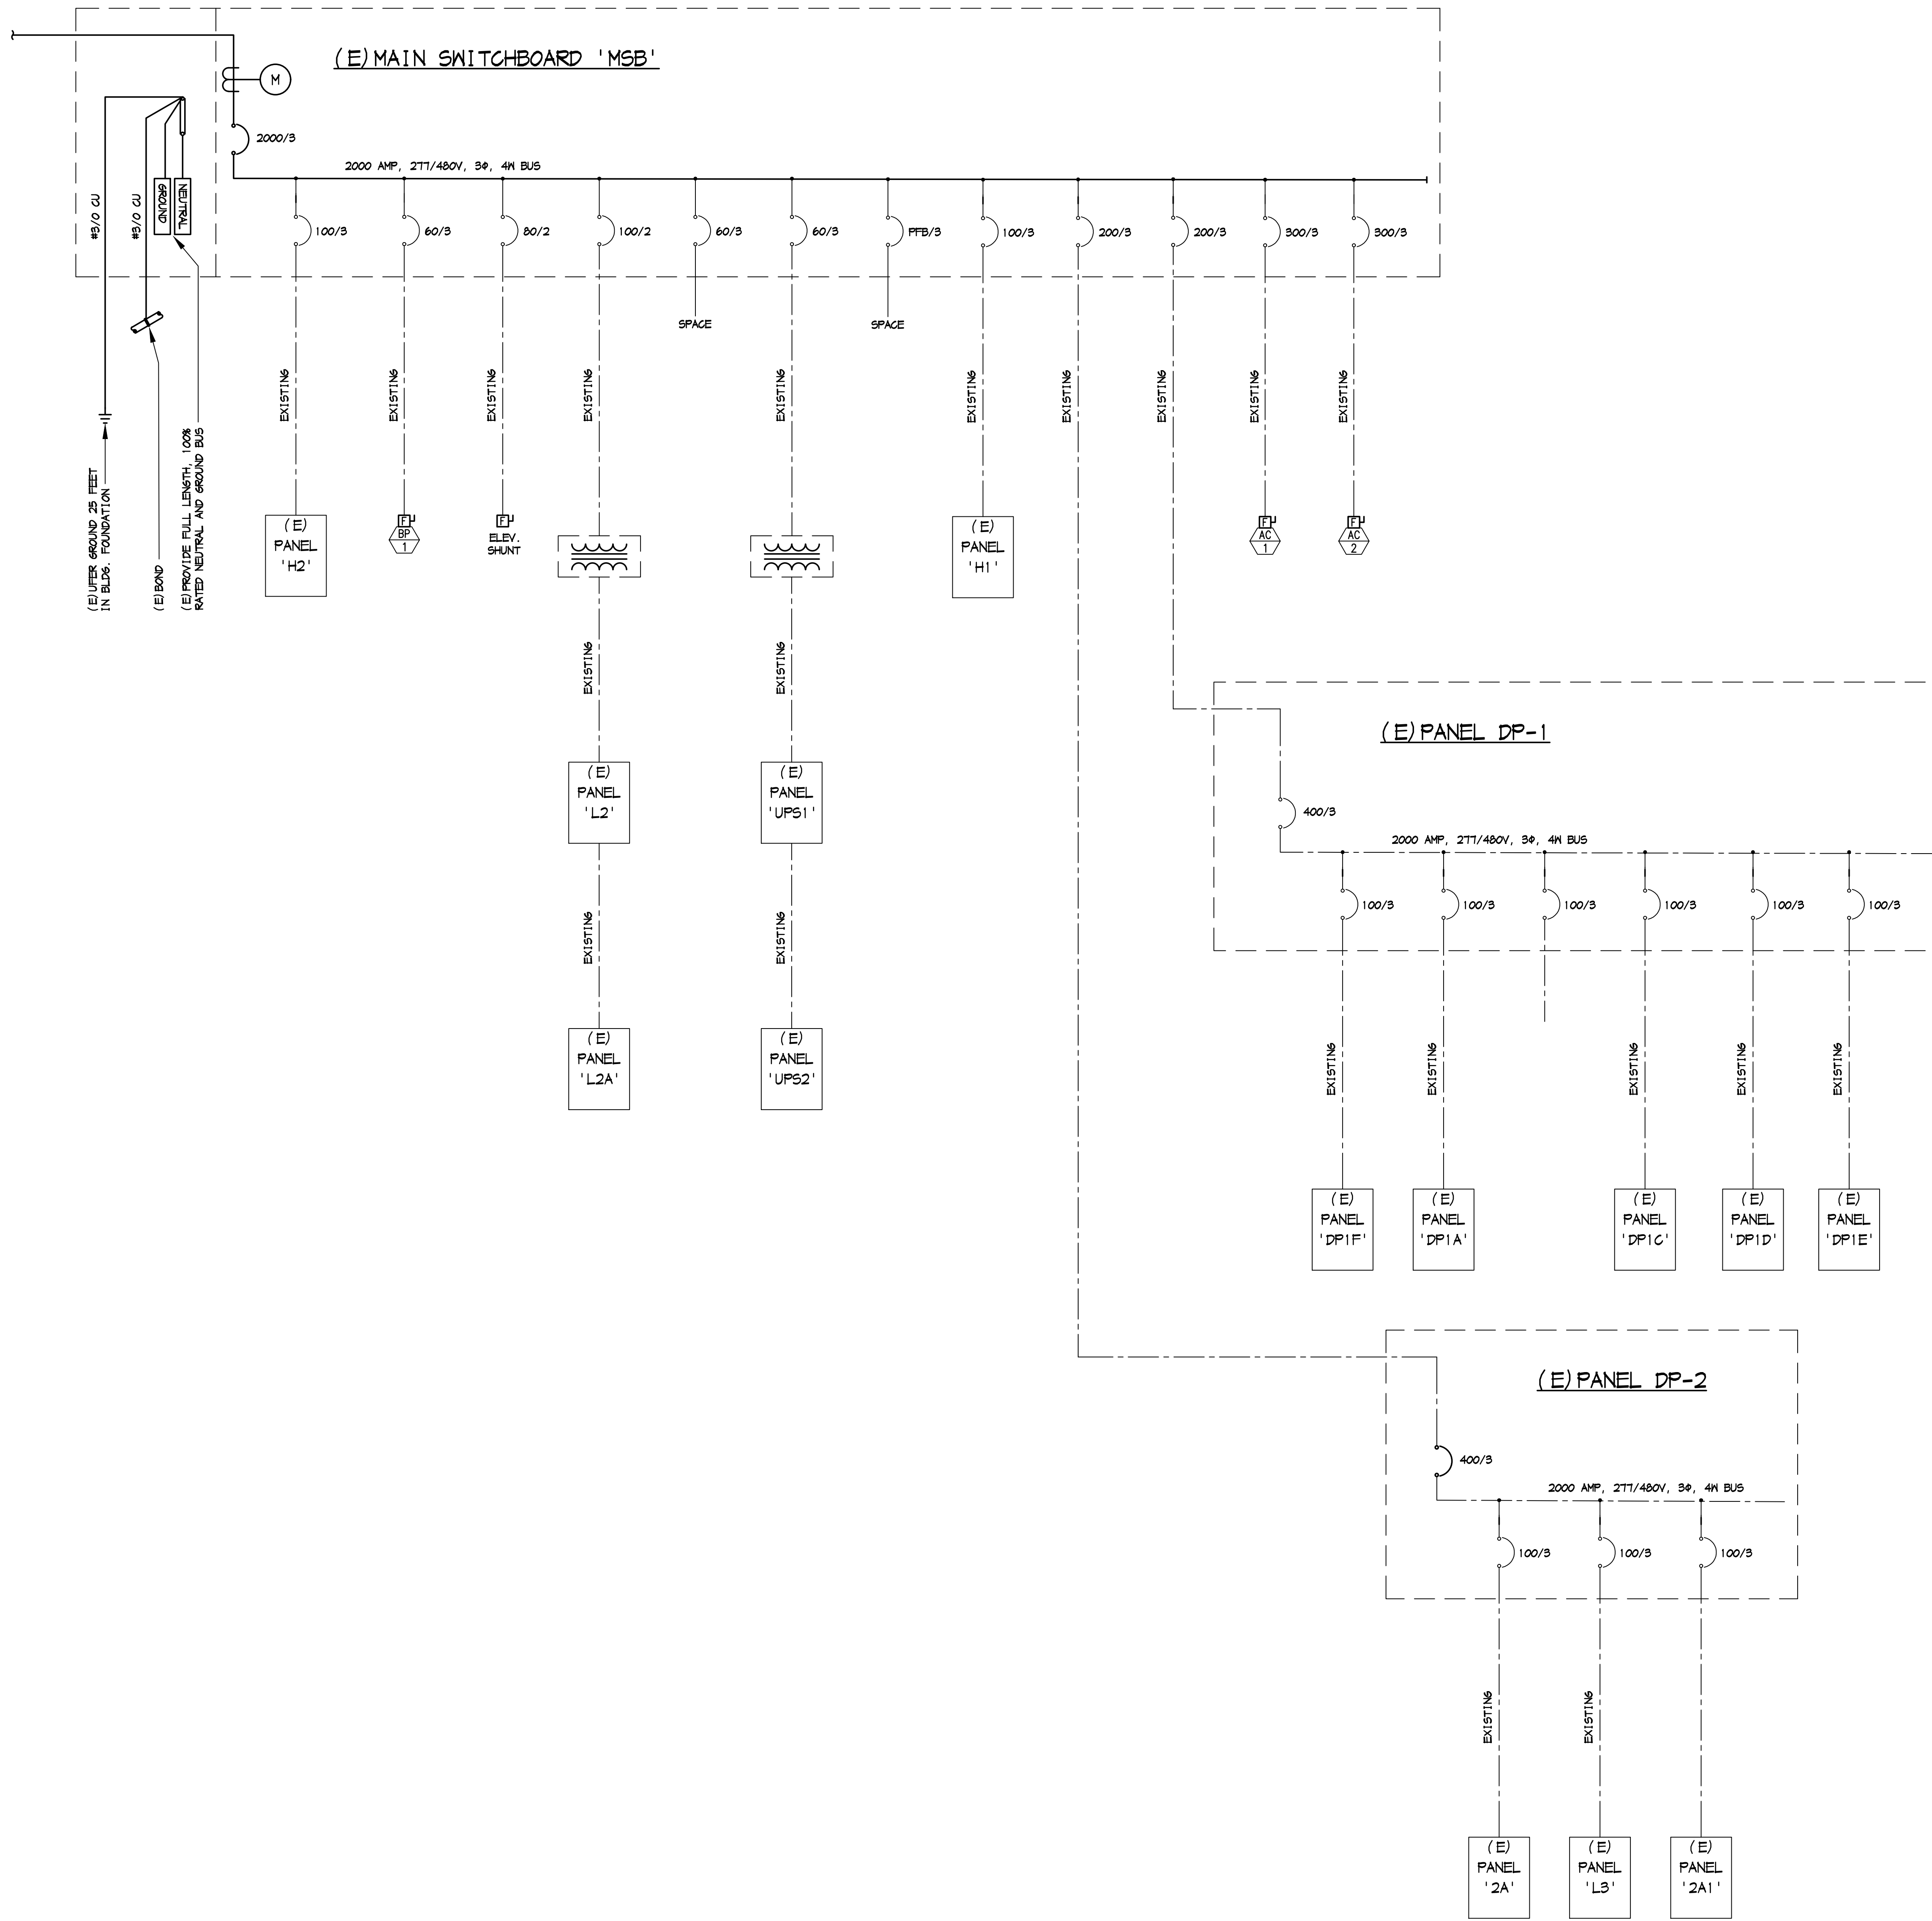
**(E) ONE LINE DIAGRAM**

NOT TO SCALE  
 (ALL EQUIPMENT IS EXISTING UNLESS NOTED OTHERWISE)

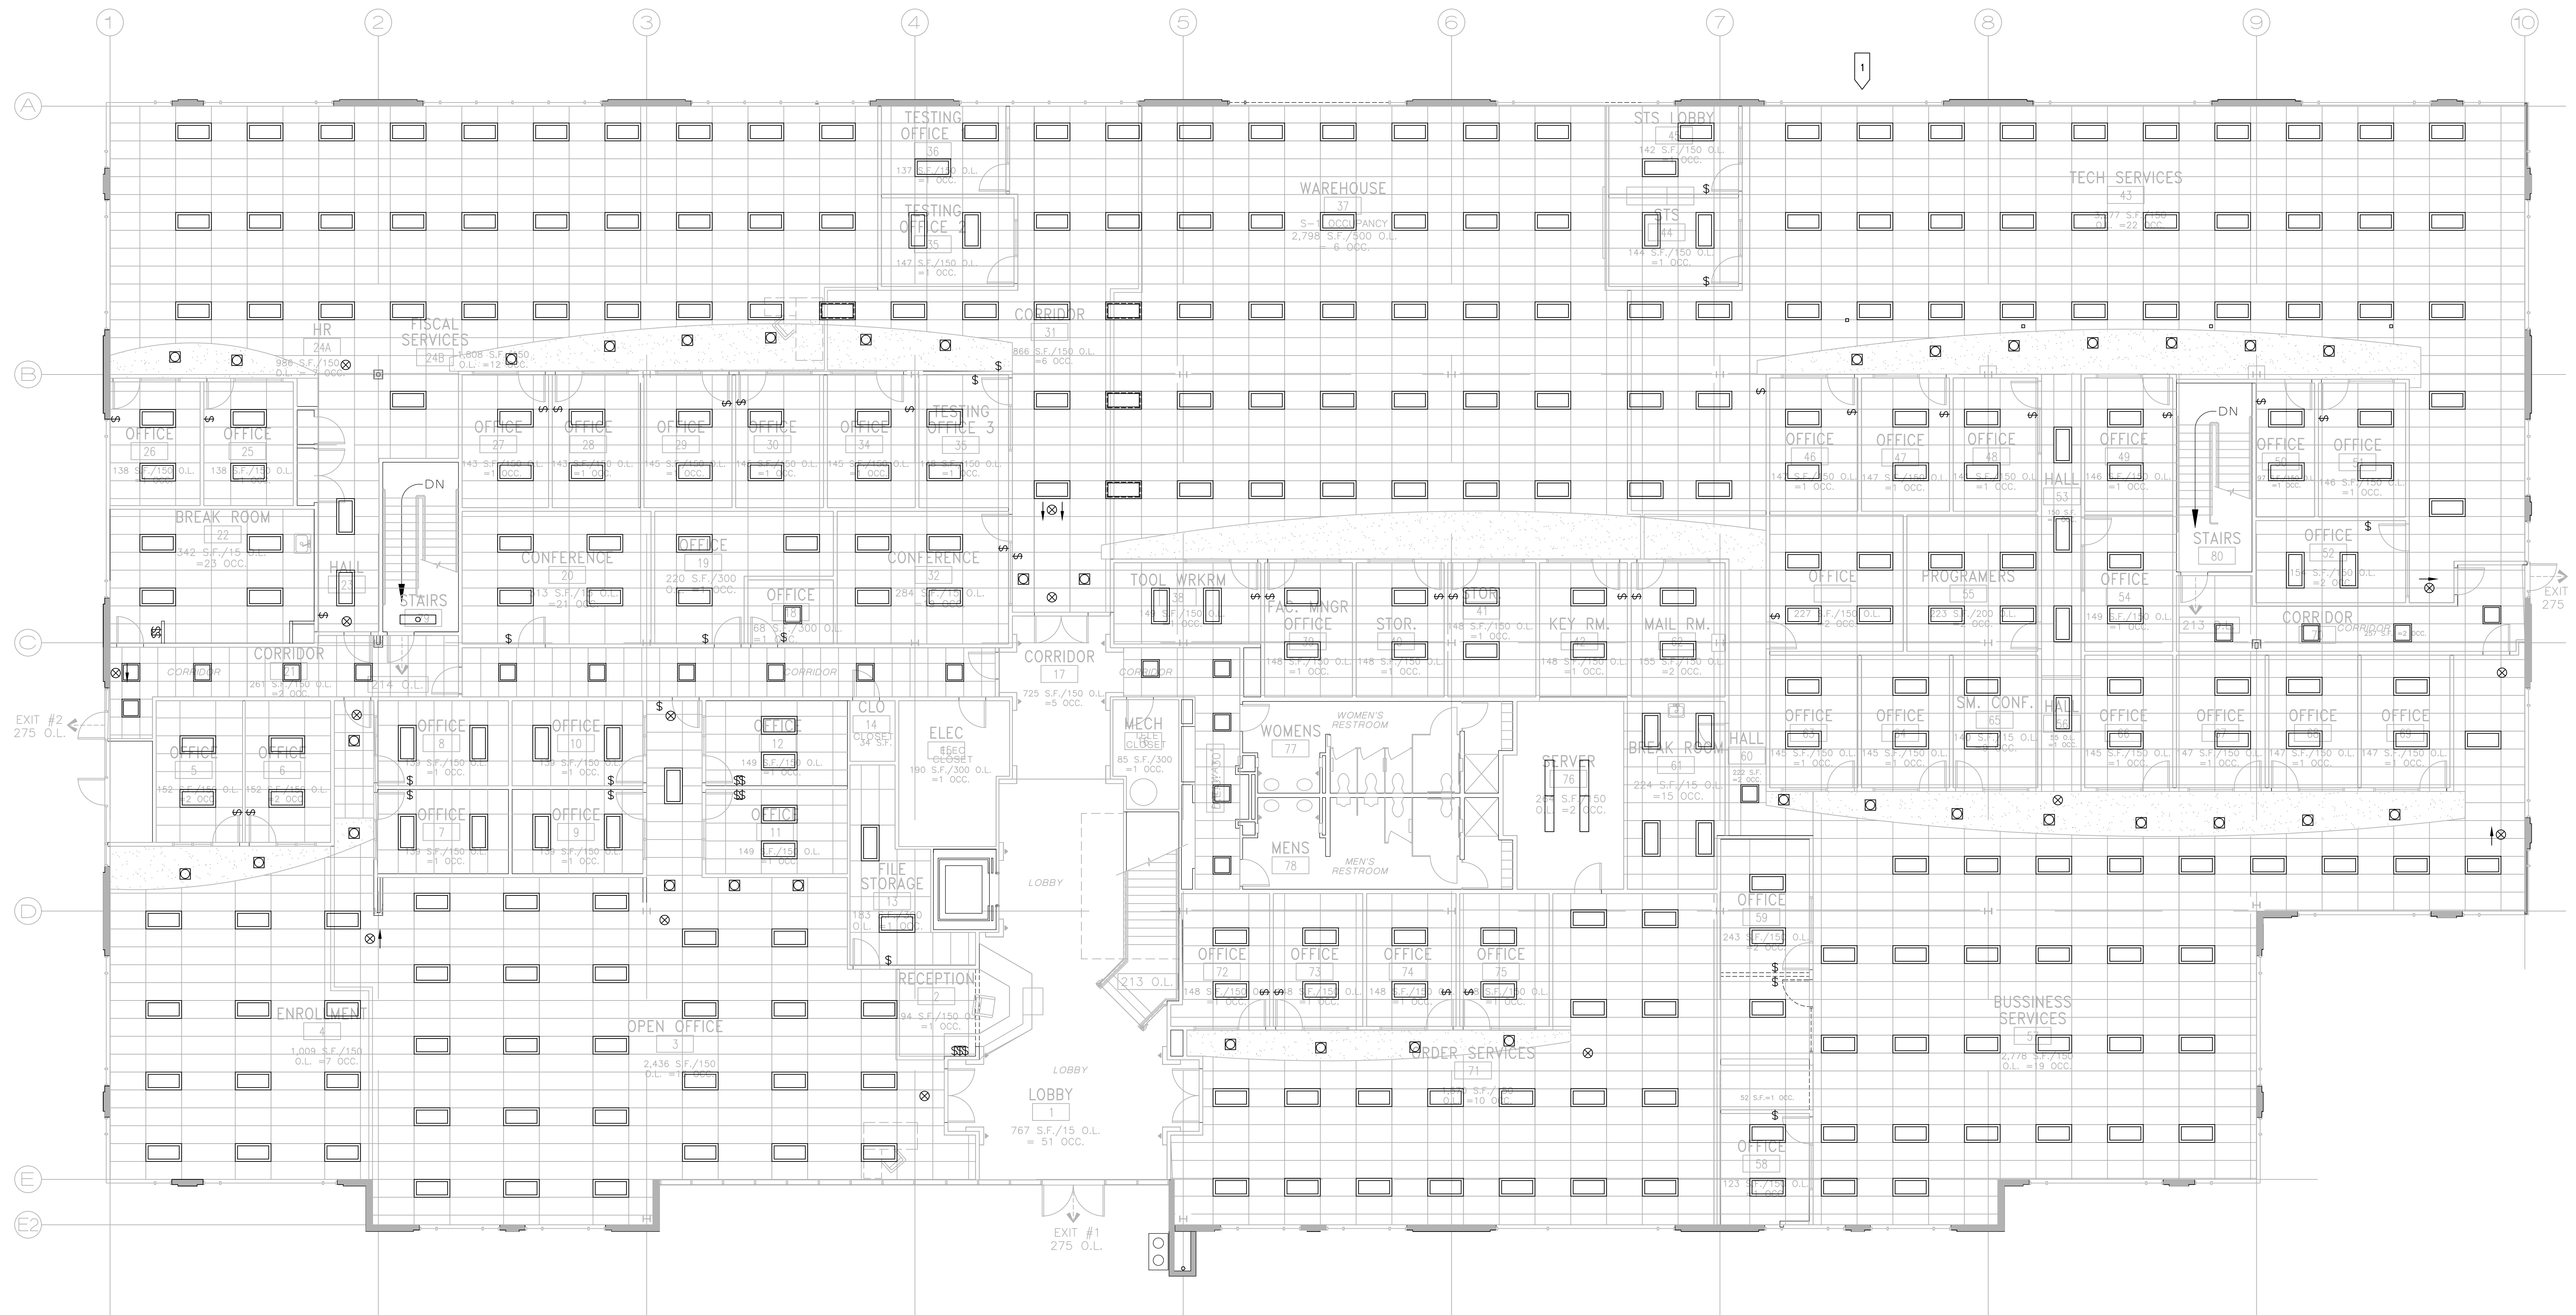
1ST FLOOR PLAN - DEMOLITION LIGHTING

- 1 ALL LIGHTS ARE EXISTING TO REMAIN UNLESS NOTED OTHERWISE (TYPICAL)
- 2 RELOCATE (E) LIGHT FIXTURES AS REQUIRED FOR (N) LAYOUT, IN AREAS AS DESIGNATED.

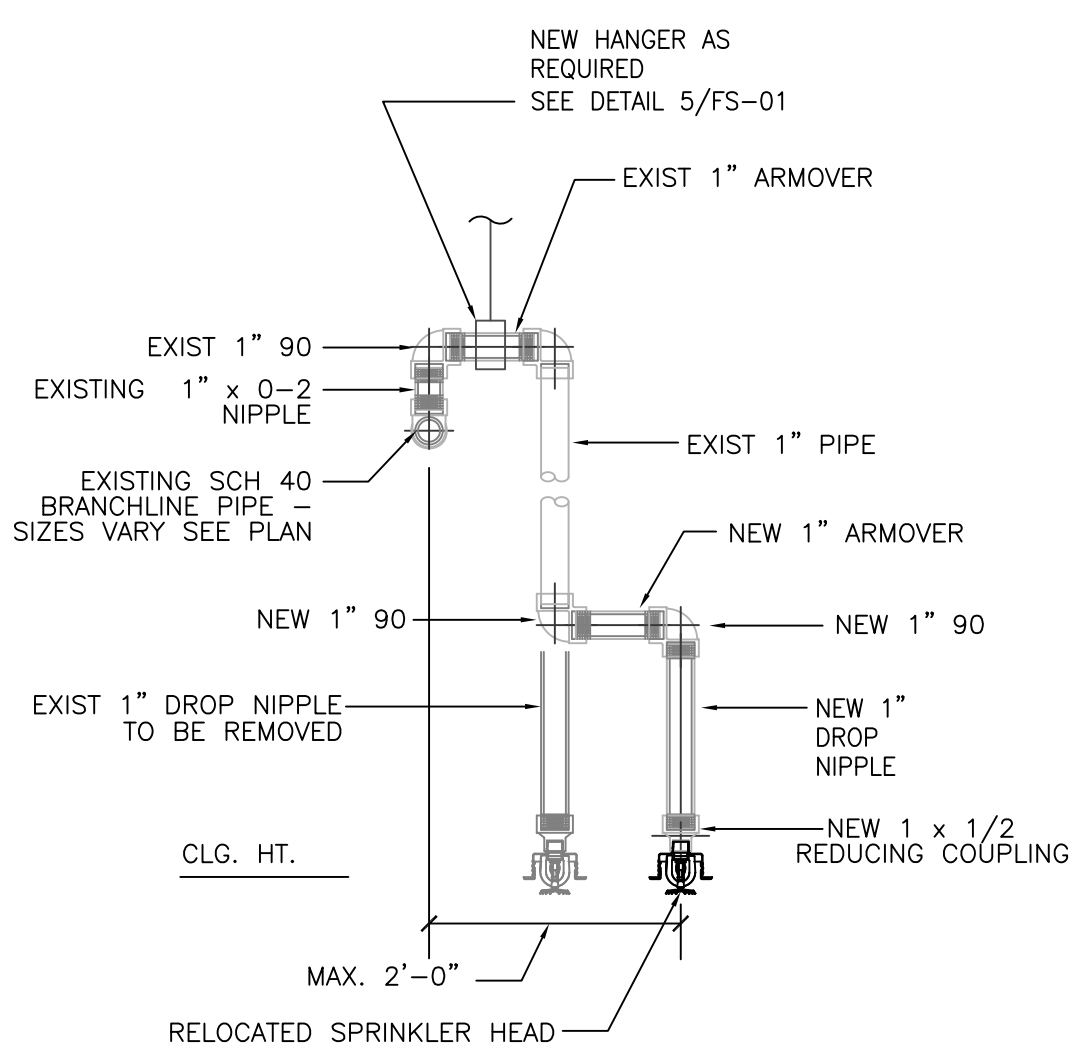
TYPICAL ARM-OVER & LINE RESTRAINING

FIGURE 25 SURGE RESTRAINER FOR STEEL OR CPVC PLASTIC PIPE TOLCO FIRE PROTECTION CATALOG PG. 19

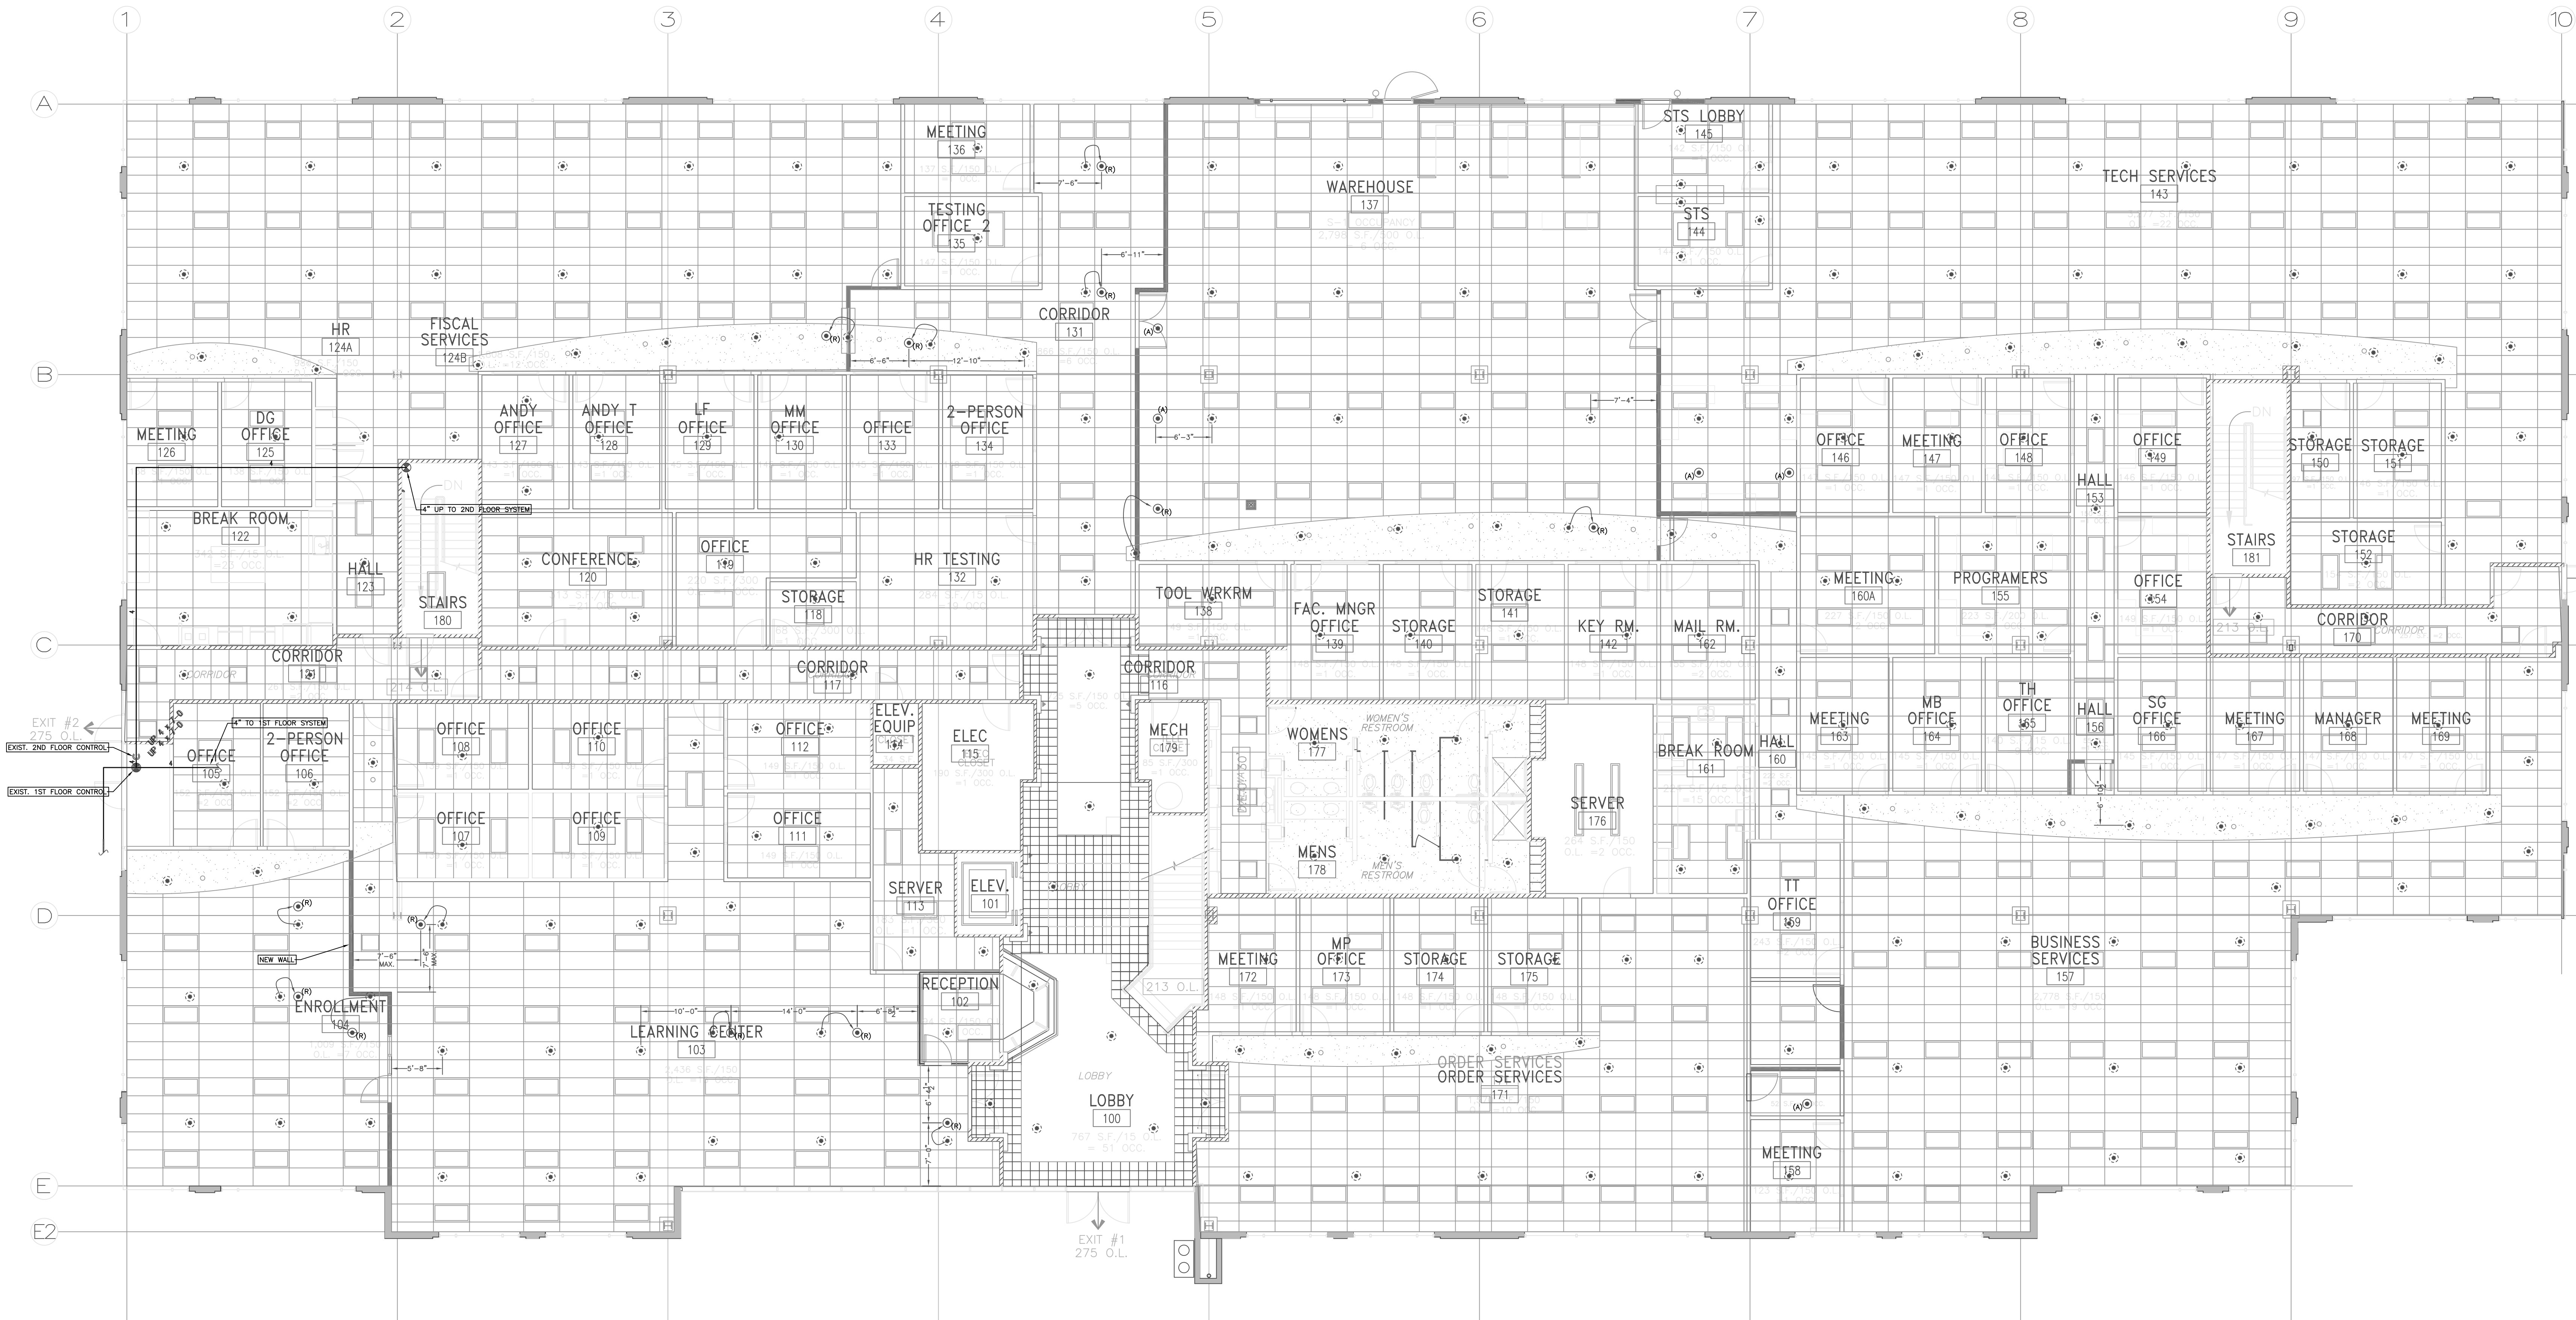
**NEW 1st FLOOR PLAN**  
 1/8" = 1'-0"

Symbol	Count	Thread	K-Factor	Description	Note
⊙	18	1/2"	5.6	TY3231 1/2 QR 155 WP PDR	ON DROP
⊕	(266)	1/2"	5.6	EXISTING 1" QR RECESSED	ON DROP

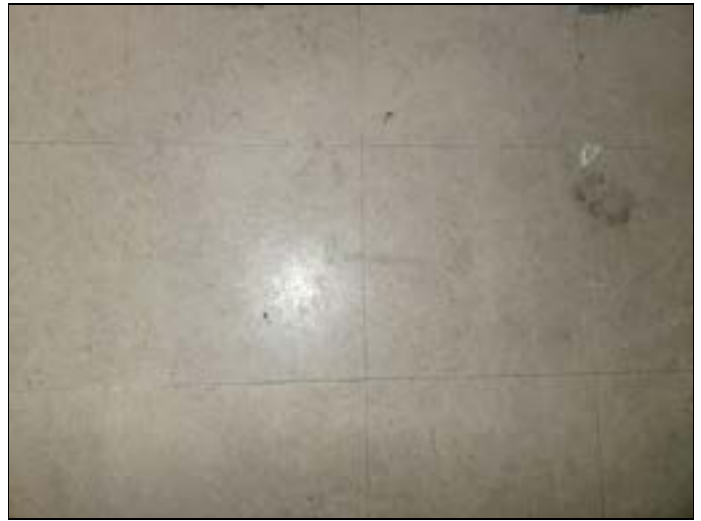
8. Samples 02A-02C: 12"x12" beige VFT with black specks and yellow mastic, second floor

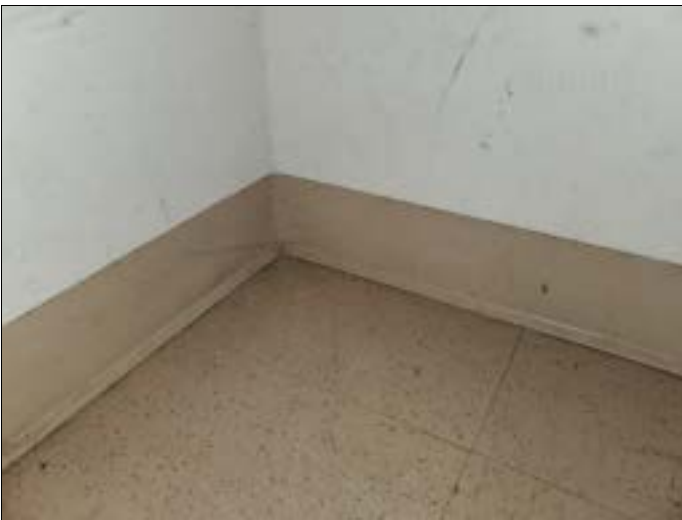
9. Samples 03A-03C: 4" beige cove base with tan mastic, second floor

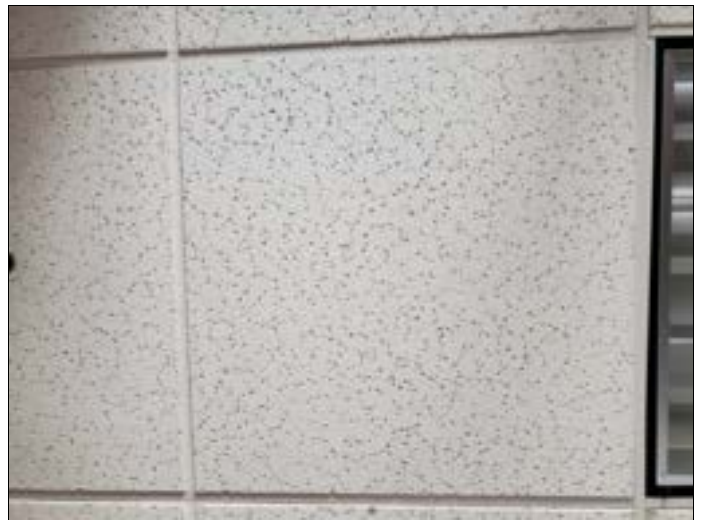
10. Samples 04A-04C: 2'x4' ceiling tile with pinhole and fissure pattern, second floor

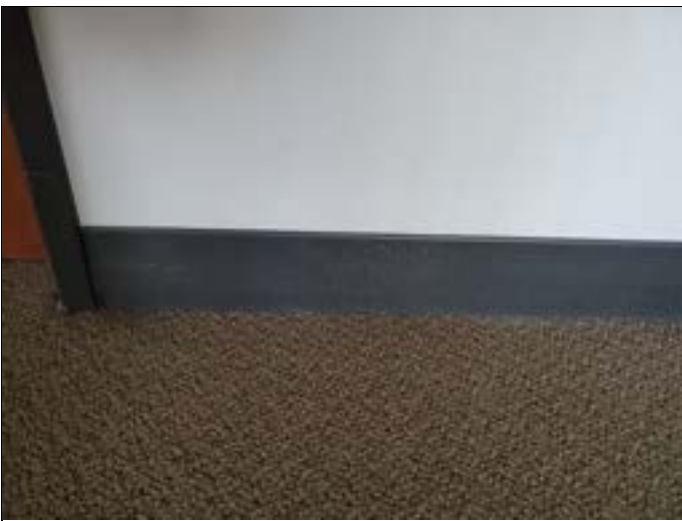
11. Samples 05A-05C: 4" brown cove base with cream mastic, second floor

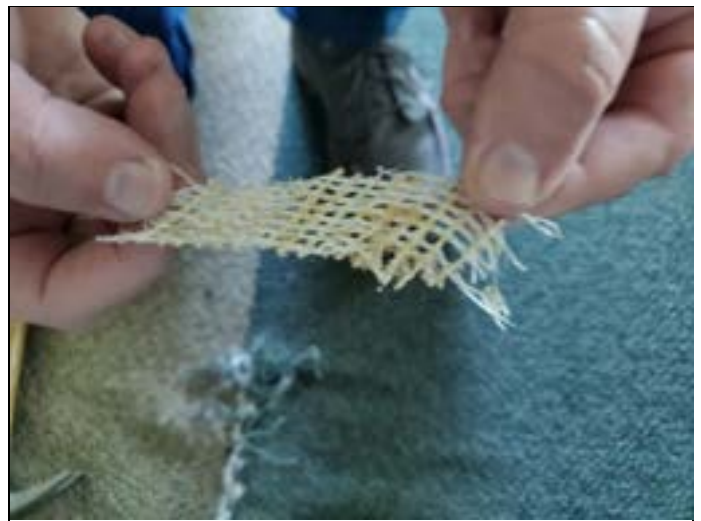
12. Samples 06A-06C: Yellow carpet mastic with white leveling compound, second floor

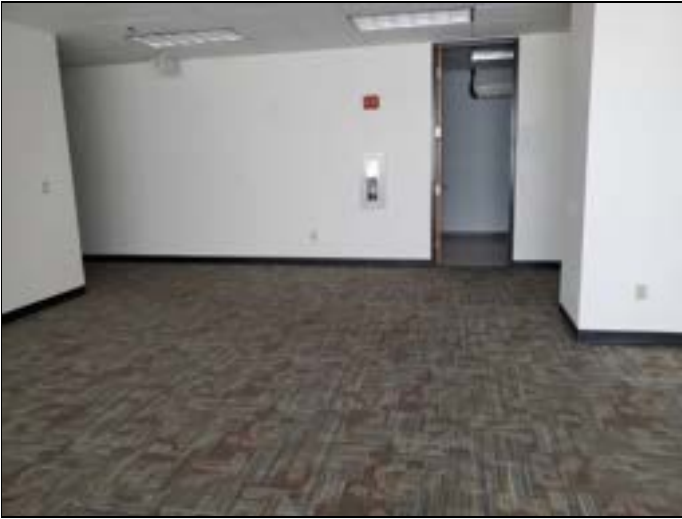
13. Samples 07A-07G: Drywall with joint compound, second floor

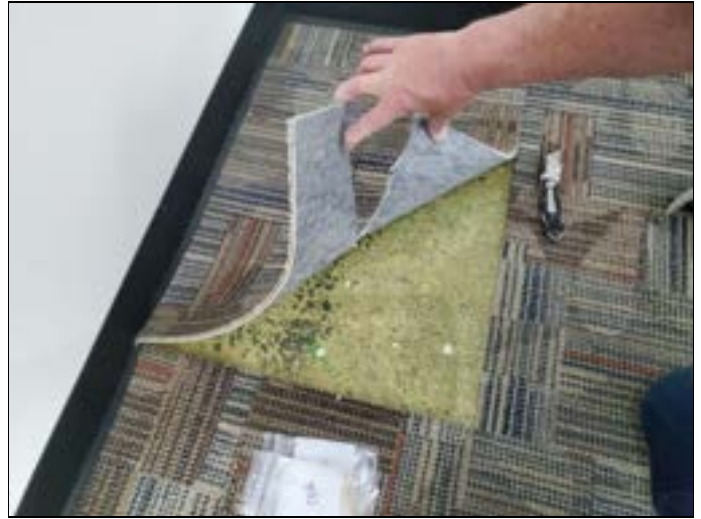
14. Samples 08A-08C: Yellow and blue carpet mastic, second floor

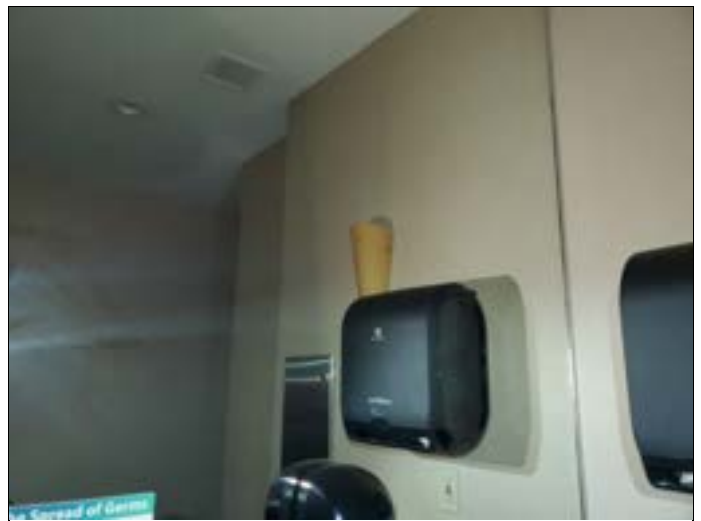
30. Assumed ACM: Mirror mastic in restrooms
